EXHIBIT E
Asbestos Survey Report

Job Location:
Fire Station #4
2222 Ben Hill Rd
East Point, GA 30344

Inspection location: Fire Station #4 at 2222 Ben Hill Road

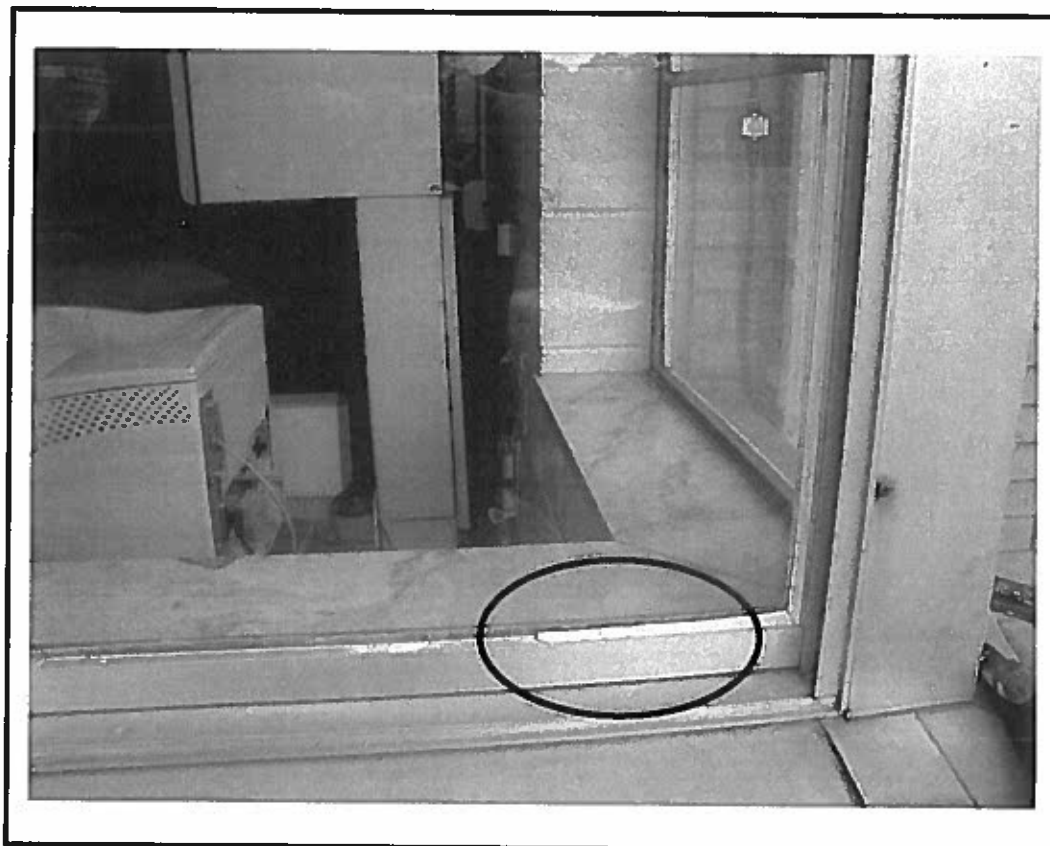
<u>Sample ID</u>	<u>Description of Material</u>	<u>Location</u>	<u>Type & Concentration</u>	<u>Category</u>
#06	Exterior Window Glazing	Captain’s Office	2% Chrysotile	Misc. - friable

Asbestos containing (2%) widow glazing putty holds in the window glass.

The owner or contractor must provide the Georgia Environmental Protection Division (GA EPD) with at least 10 days written notification prior to disturbance of Regulated Asbestos Containing Material (RACM). And the removal to be performed by a GA EPD Licensed Abatement Contractor. All asbestos waste debris must be disposed at a permitted landfill using the proper waste manifest.
